SMALL PARTICULATE CONTAMINATION SURVEY OF GENESIS FLIGHT SAMPLE 61423. K. R. Kuhlman¹, M. Schmeling², C. P. Gonzalez³, K. K. Allums⁴, J. H. Allton⁵, and D. S. Burnett⁶; ¹Planetary Science Institute, 1700 East Fort Lowell, Suite 106, Tucson, AZ 85719; kim@psi.edu, ²Loyola University Chicago, 408 Flanner Hall, 60660, ³Jacobs, NASA Johnson Space Center, Houston, TX 77058, USA, ⁴HX5, LLC – Jacobs JETS Contract, NASA Johnson Space Center, Houston, TX 77058, ⁵NASA/Johnson Space Center, Houston, TX 77058; ⁶California Institute of Technology, Pasadena, CA, 91125.

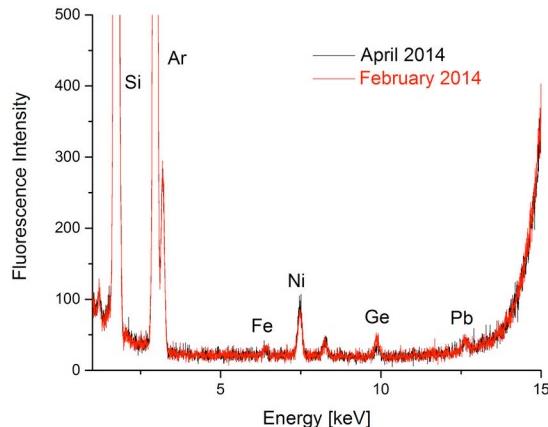
Analyses before and after the application of the replicas are shown in Figure 1. The third spectrum taken after further IPA and UPW cleaning is shown in Figure 2 for comparison. Two observations can be made. First, it does not appear that the extraction replicas leave contamination on the surface that would skew large area analyses. Second, multiple cleaning steps appear to reduce the germanium contamination on the surface.

Figure 1. TRXRF analyses before (red) and after (black) cellulose acetate replica cleaning. No evidence of organic residue is observed.

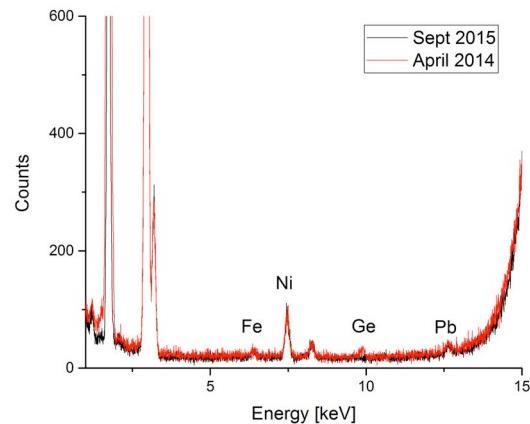
Figure 2. TRXRF analyses before (red) and after (black) additional UPW and IPA cleaning steps. Note the reduction of Ge contamination.

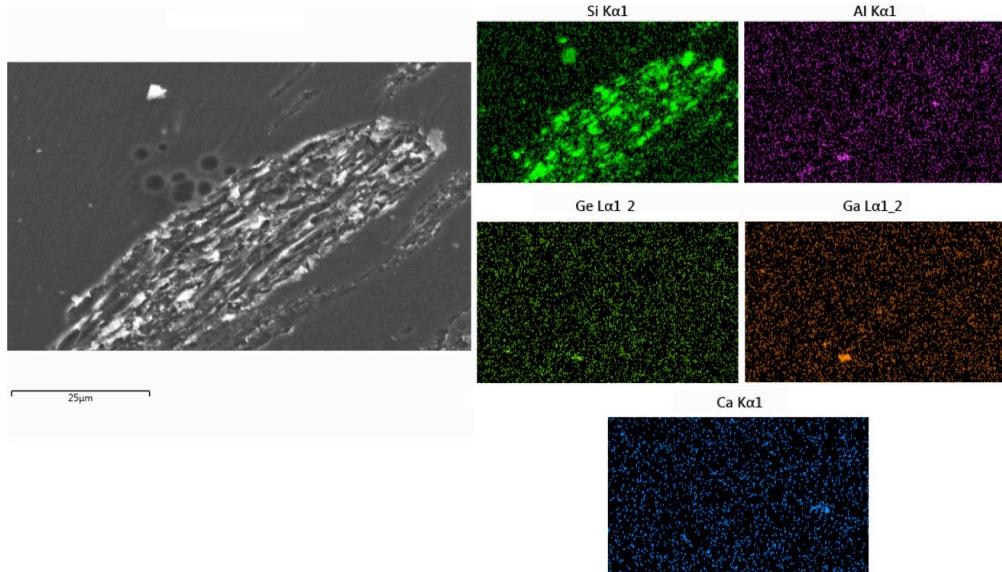
Analysis of Extraction Replicas: The extraction replicas were examined using SEM and EDX to see what types of particles were removed from the surface of 61423. The SEM image of an example of a silicon feature that was removed is shown in Figure 3. EDS mapping shows that the replica has removed a great deal of silicon from the feature, which apparently incorporated particles of aluminum, germanium, gallium and calcium during the crash.

Figure 3. SEM image of a cellulose acetate extraction replica of Genesis sample 61423 and corresponding EDS maps for silicon, aluminum, germanium, gallium and calcium.

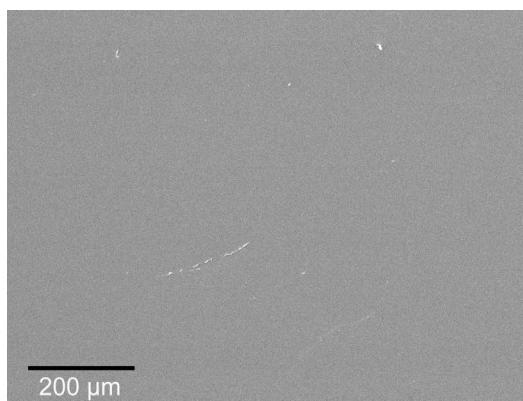
Small Particle Survey: An area of the sample that appeared “clean” using optical microscopy was selected to see what types of very small particles remain after multiple cleaning steps (Figure 4). 53 particles were analyzed using EDS with a 10 keV electron beam. The results are shown in Figure 5. Silicon is the most predominant contaminant remaining.

Figure 4. SEM image of nominally clean area of 61423 for small particle survey.

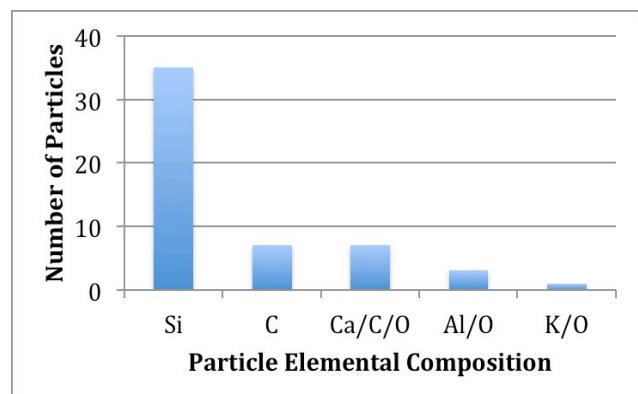
Figure 5. Composition of the 53 particles analyzed in the small particle survey of Genesis sample 61423.
